## Winter Roofs and Ice Damming – Signs of Heat Loss

### Do you have a lot icicles hanging from your roof?

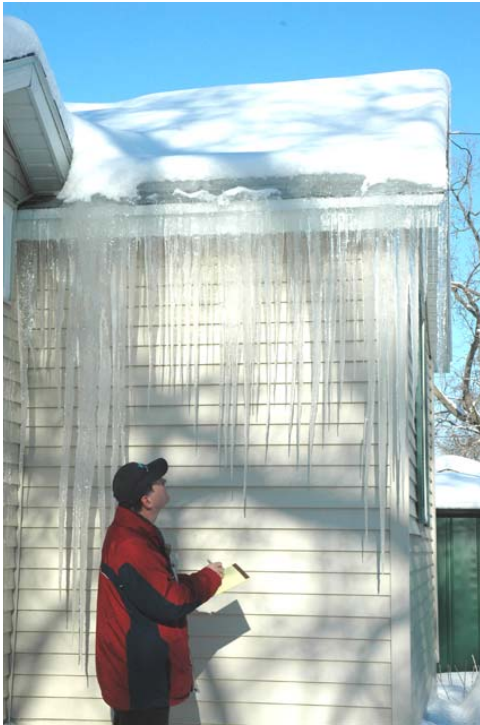
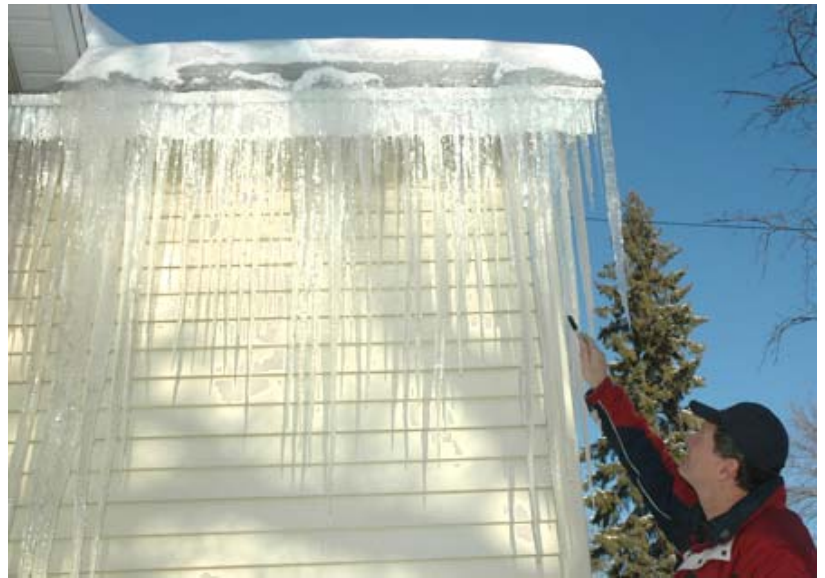
It has been quite a winter with large amounts of snow falling since the beginning of December. With a snowy early start to winter, we see a lot of roofs with ice damming and icicles draping down from gutters. Some icicles may form because the sun does radiate onto the roof shingles, melting the snow and the natural draining of water off of the roof occurs. As little as one or two inches of snow accumulation on the roof with freezing temperatures can allow for ice dams to form. Look around at our homes and compare buildings that have a lot of ice damming or icicle issues and those that do not. A properly ventilated and insulated roof system will have snow on it but no signs of ice damming or icicles. Why? The roof is cold. While heating our homes during the winter, heat naturally rises within and wants to cool to the outside air which is at a lower temperature. The heated air will find any gap, hole or pathway and create an escape to the outside into the attic or exterior walls. Heated air that escapes our home heats the roof sheeting and causes the snow to melt. Melted snow travels down into gutters or the bottom edge of the roof or roof eaves then cools off and forms ice. The problem compounds as more ice builds up or “dams up” and wants to get under the roof shingles and then water can potentially leak into the house. Roof damage can occur and even interior and exterior walls can be affected by this problem.

How does heat get into my attic? Several pathways can lead into the attic which can increase the home's interior air leakage. Anything that penetrates the attic can cause potential air pathways. Bathroom and range fans that just vent into attic space can cause the ice damming problem too. What about ice dam roof material? It helps prevent damage to the roofing materials from ice damming but does not prevent the ice from forming. Heat loss is the ice dam culprit! If you are helping reduce the snow and ice load with a roof rake – be careful not to damage the roofing shingles or membrane. A few years ago the snow on flat roof at the office was casually shoveled off. The next spring there were roof leaks because holes were punctured in the membrane. If you are not sure how to clear the snow from your roof and your roof may be difficult to reach, contact a roofing professional for help. You can get your snow on the roof removed safely and also

prevent possible roofing damage. What about roof ventilation? The roofs on our homes and buildings need to properly vent any heat buildup in attic spaces. A properly vented roof will slowly and evenly dissipate any heat by natural ventilation. Soffit vents that protrude into the attic, roof caps vents and ridge vents all contribute to good roof ventilation. When high heat loss into the attic results from inadequate insulation or when high air leakage is present, our roofs cannot naturally ventilate and dissipate escaping heat. How can I fix the problem? A good opportunity to find the air pathways and improve insulation is when you replace your roof or doing a remodeling project. Your home can also be tested for heat loss without re-roofing or remodeling. The key is in finding air pathways, proper sealing and insulation for the roof system. A Home Performance assessment can test for air infiltration into the attic, walls and other areas of your home. Diagnosing ice damming problems include finding air pathways, evaluating insulation and attic venting. Recommendations are then made for cost effective solutions to remedy the problems. Just adding more insulation may not solve ice damming problems. A whole house approach will make your home more comfortable, durable and energy efficient.
